NOVABONE® MORSELS

CLINICAL CASES

SINUS LIFT AND BONE GRAFT

BONE REGENERATION IN IMPLANT THERAPY

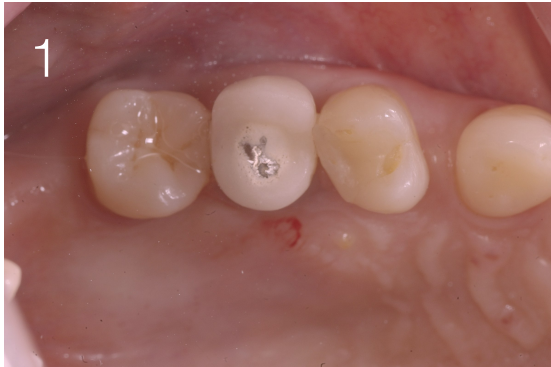
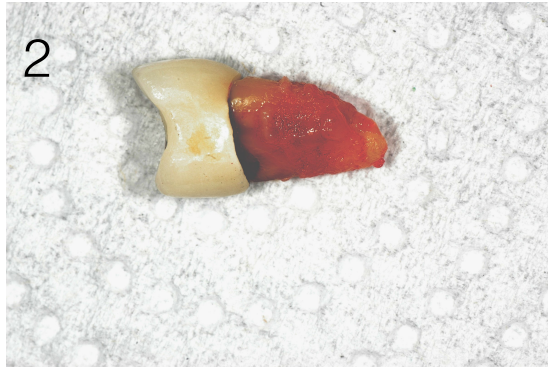
51 years old female patient lost tooth number 15 for endodontic and periodontal reasons (Fig 1, 2, and 3). Two months after the extraction and implant with sinus elevation was performed (Fig 4). The implant failed after 4 months. The site cleaned and the patient wait two months to repeat the treatment (Fig 5). Orthodontic treatment was done to distribute the spaces and to improve the occlusion.

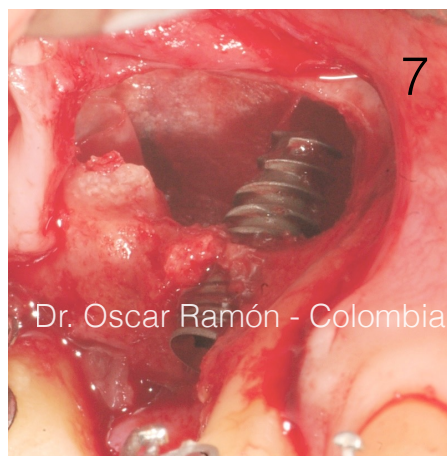
The site was reopened and the sinus elevation the membrane was perforated. One Dynamix Implant (Cortex Dental Ind.) was estabilized usin a small piece of native bone. (fig 6). The membrane was repaired with a collagen membrane (Fig 7) and Novabone Morsels (NovaBone Products) was used for bone regeneration (Fig 8). A collagen membrane (3Biomat Inc.) was used to protect the bone and the flap was sutured (Fig 9 and 10). Control Rx was done (Fig 11).

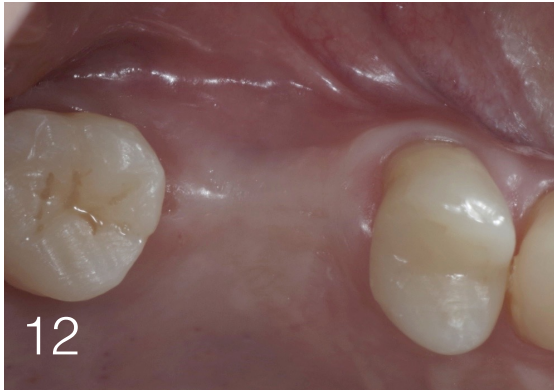
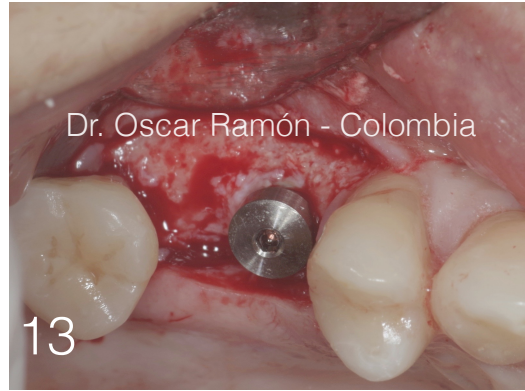
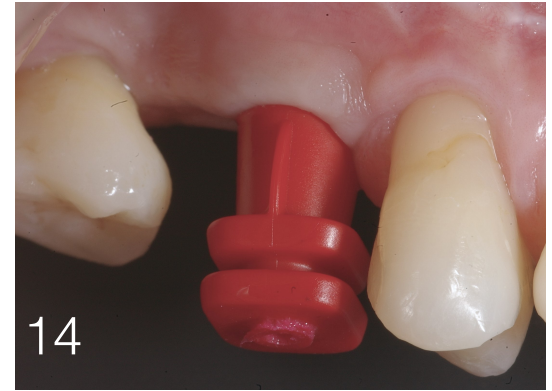
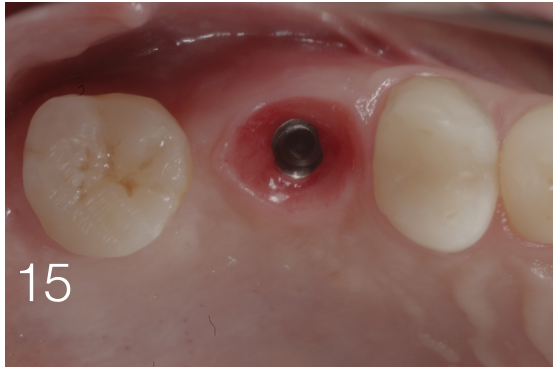
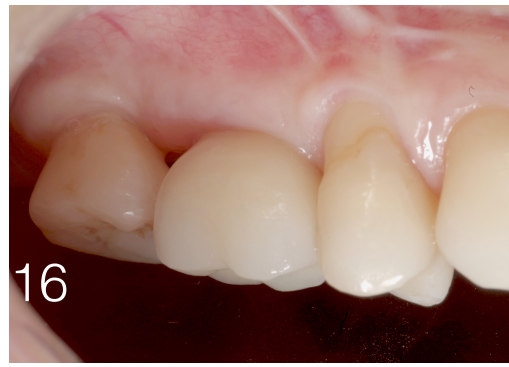
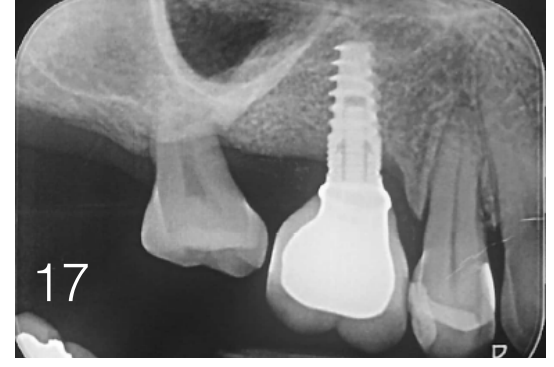
After the healing time the site was re-opened and a 3mm healing cap was used (Fig 12 and 13). An impression was taken using the snap technique (Fig 14) and a tissue profile was created with a temporary restoration (fig 15). Final restoration and control Rx after two years of follow-up (Fig 16 and 17).

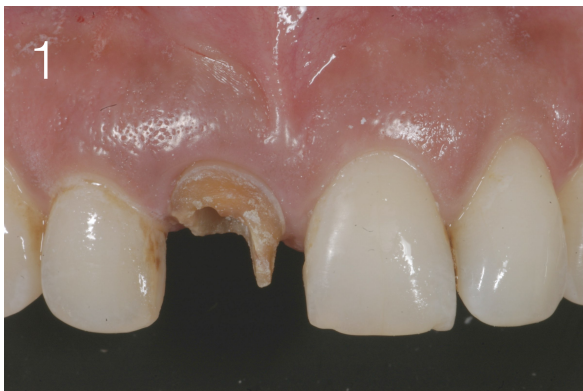
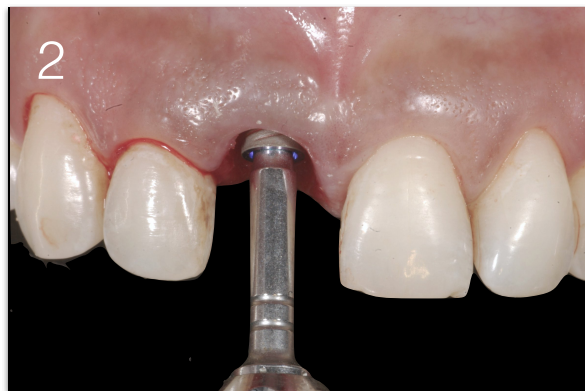
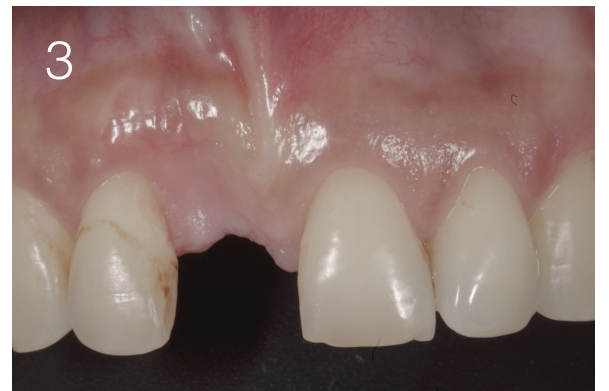
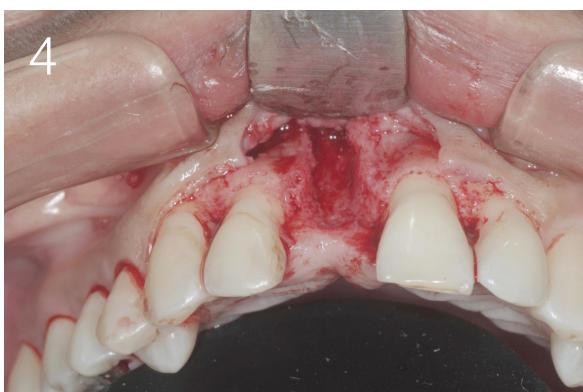
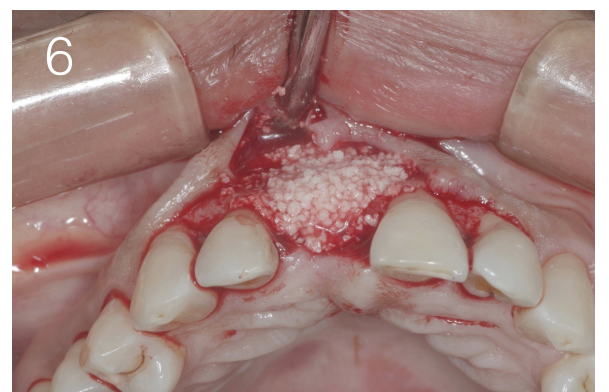
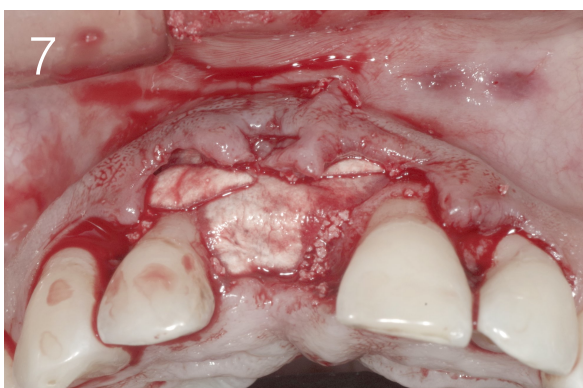
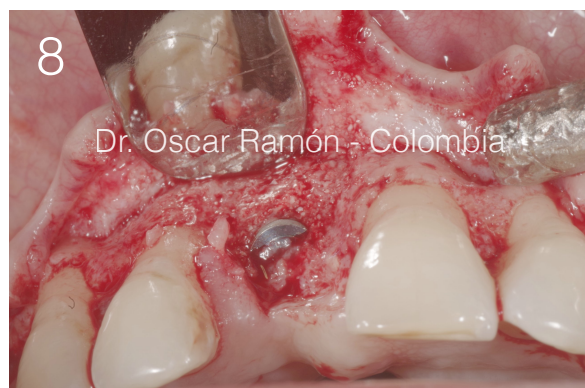
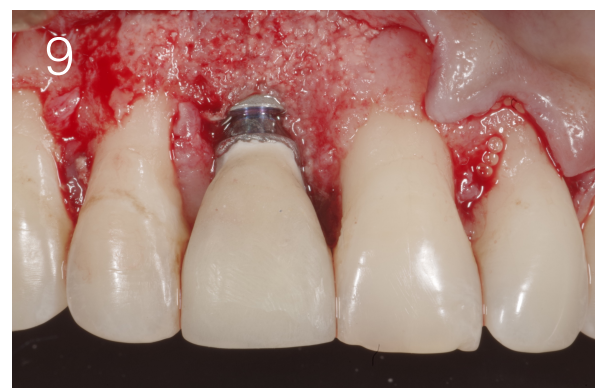
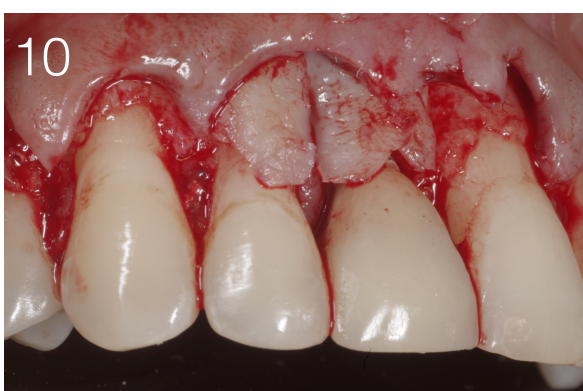
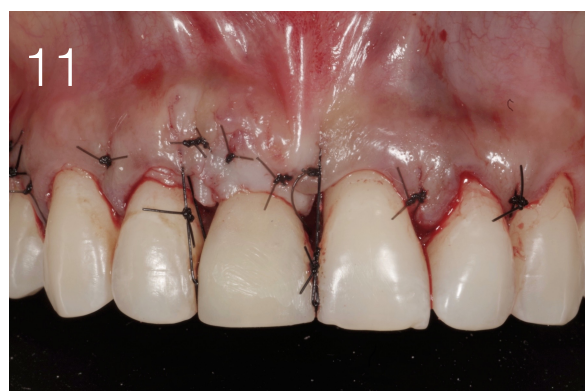
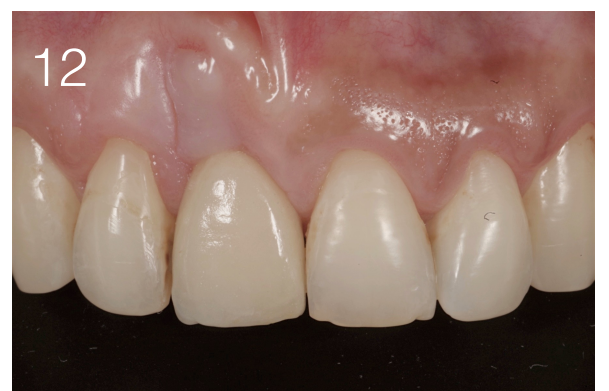
42 years old female heavy smoker with a root fracture in tooth number 11 (Fig 1). The root was extracted and a postextraction implant was performed (Fig 2). The implant was lost two months after surgery and a large defect in the hard and soft tissue was generated (Fig 3). After the time the flap was opened and a big bone deficiency was found (Fig 4). At Dynamix Conical implant (Cortex Dental IND.) was inserted in the residual bone (Fig 5), a complementary bone regeneration procedure was done using Morsels (NovaBone Products, Fig 6) and a collagen membrane (3Biomat Inc, Fig 7). After 5 months the site was re-opened. the implant was loaded with a temporary restoration and a connective tissue graft was done to improve the soft tissue (Fig 8, 9, 10 and 11). After 3 months a final Crown was delivered (Fig 12).

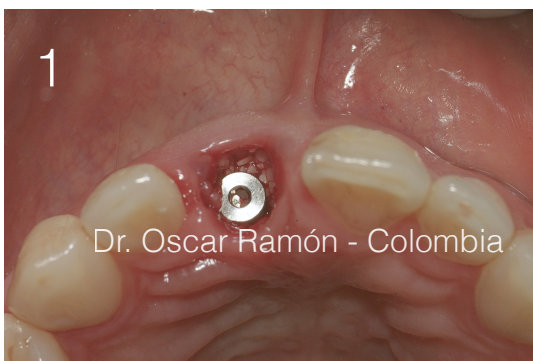
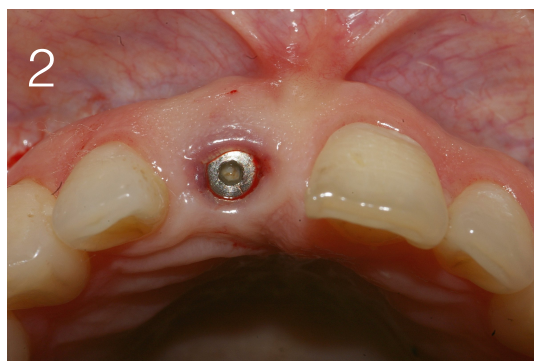
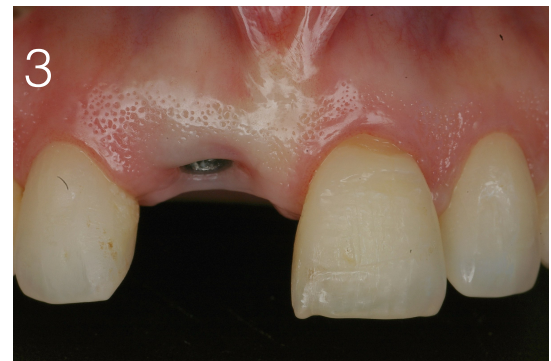
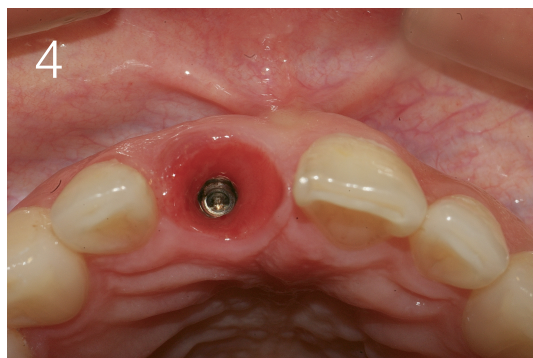
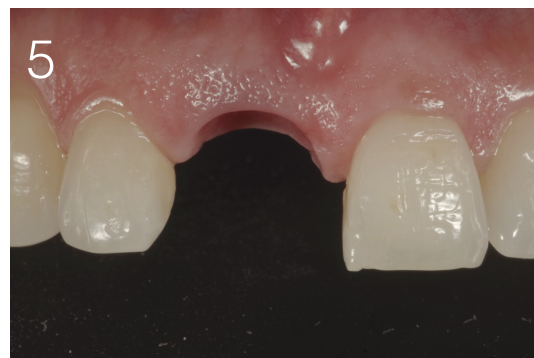
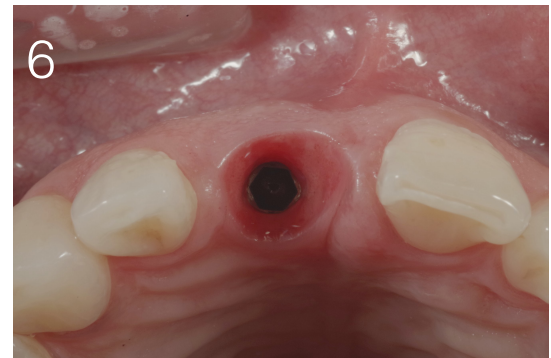
46 years old female with non medical pre-existing condition was referred for implant management in tooth 11 due to a non-restorable root fracture. A immediate implant was inserted in a palatal position. The gap between bucal plate and the implant surface was filled with novabone Morsels to preserve the dimensions of the ridge and the profile of the soft tissue (Fig 1). A 3 mm healing cap was used to seal the socket (Fig 2 and 3). The soft tissue profile was managed using a temporary crown (Fig 4 and 5). The case ready for final restoraion three years after the implant was inserted (Fig 6).
